RE: U-Pick-It
Kansas City, Missouri
EPA RCRA ID No.: Non-notifier

REPORT OF RCRA COMPLIANCE EVALUATION INSPECTION

U-PICK-IT

7700 E. Winner Road
Kansas City, MO 66103
(816) 241-7548

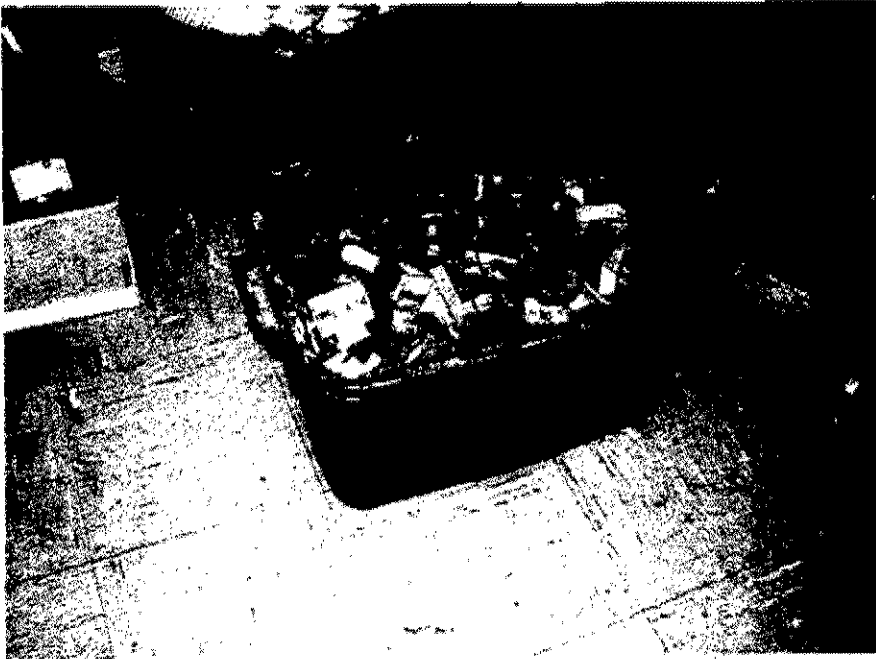
PHOTO 1, 2/9/2012 (facing N) – Yard Office – One unlabeled approximately 3/4th full 10-gallon tub of mercury switches containing the mercury ampules. D. Newsome

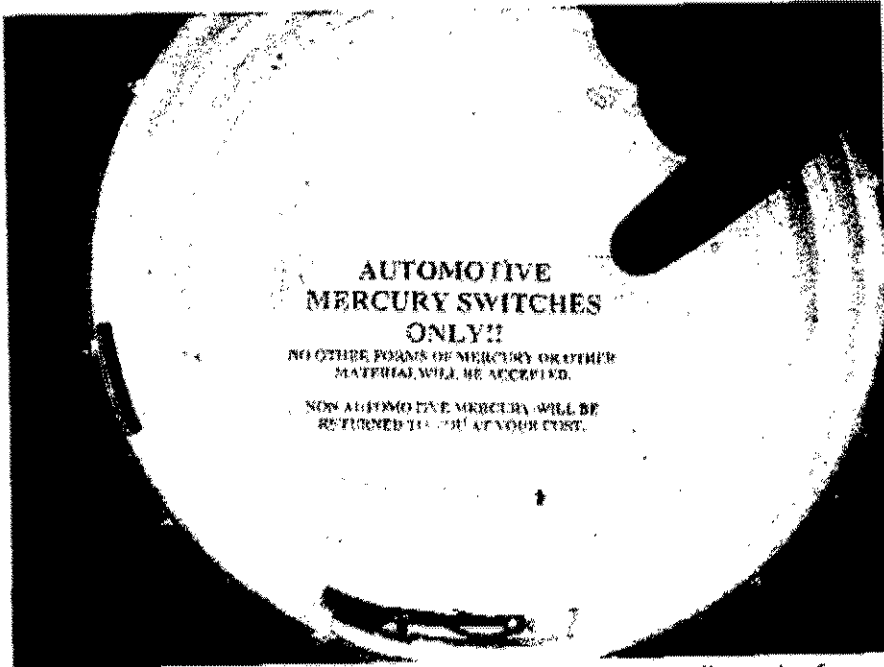
PHOTO 5, 2/9/2012 – Yard Office – Approximately 1-gallon tub of mercury ampules that had been removed from the mercury switches. Inside the tub is shown in photo 4. D. Newsome

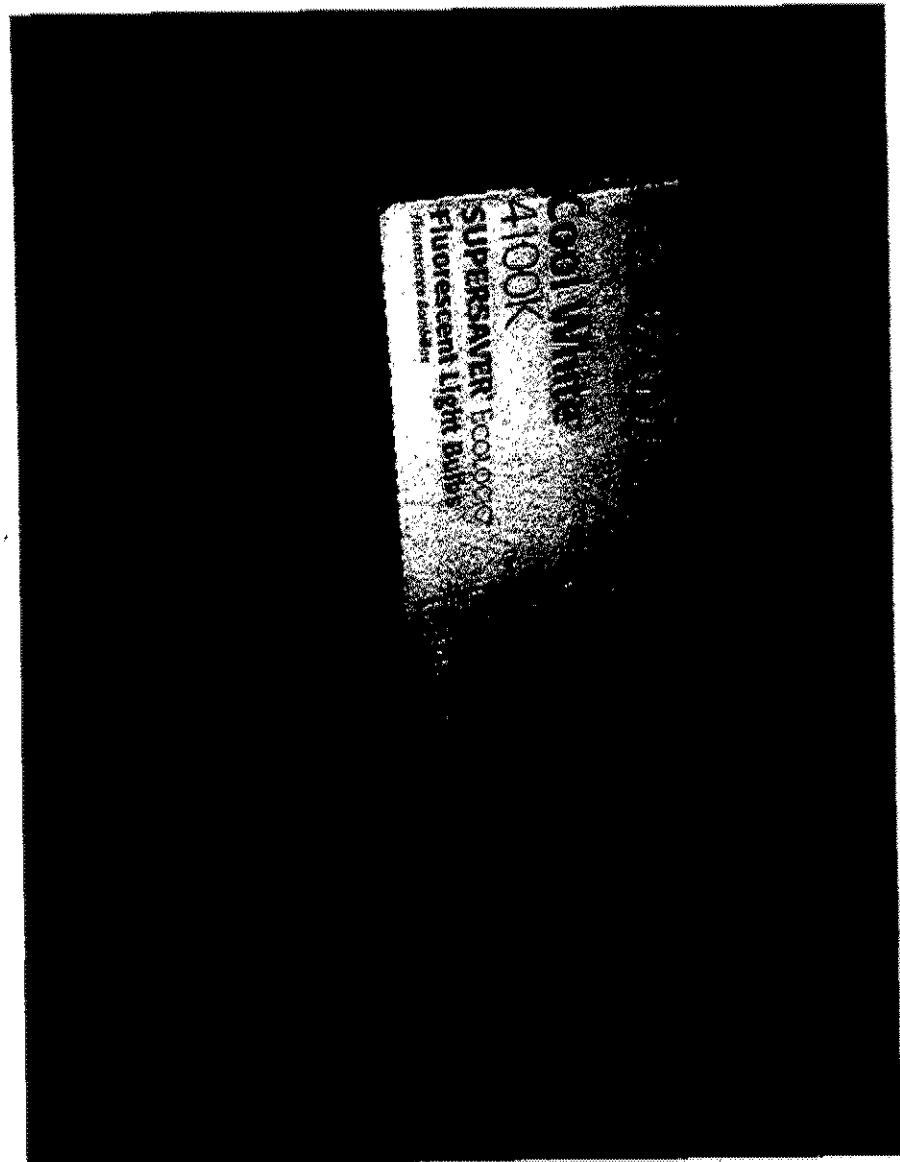
PHOTO 6, 2/9/2012 (facing SE) – Telephone System Room – One open unlabeled box of 11 spent lamps being stored. Inside the box is shown in photo 7. D. Newsome

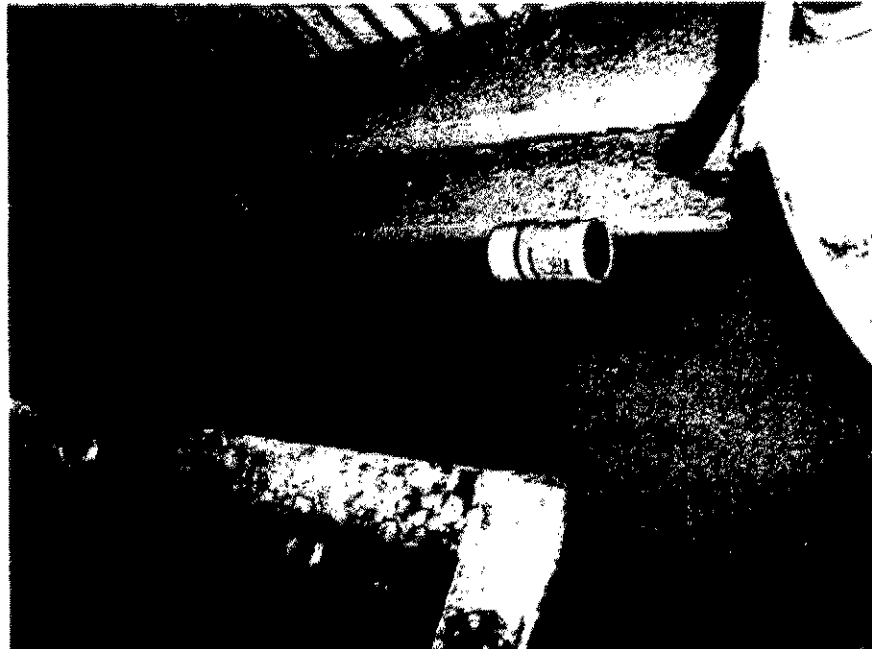
<p>Waste Fuel in Tank Containment / Possible Hazardous Waste Determination - I observed about an inch of waste gasoline in the storage tank containment, along with spent gasoline filters (see photos 8 and 10 and waste stream #4). Mr. Moran stated that the waste gasoline will either be pumped out by Heritage-Crystal Clean when they collect the used oil, or it will be cleaned out when they have the fuel storage tank cleaned again. I provided Mr. Moran with the MDNR <i>Managing Gasoline Dispenser Fuel Filters and Wastes Associated with the Operation of Fuel Dispensing Systems</i> fact sheet (see attachment 12). After the inspection and further review of the fact sheet, it states that the Missouri Department of Agriculture 2 CSR 90-30 citation states that "Water or product shall not be allowed to accumulate within any secondary containment facility, this includes dikes and remote impoundments. Accumulated water and/or product within a secondary containment facility shall be removed and disposed of in a manner that is in compliance with applicable rules of the Department of Natural Resources." Based on this fact sheet information, how the waste fuel in the containment will be disposed may be a solid waste, and therefore, a hazardous waste. It should be noted that according to 10 CSR 25-11.279(B) → 40 CFR 279.10(d), mixtures of used oil and fuels are subject to used oil regulations.</p>

PHOTO 10, 2/9/2012 (facing NE) – Storage Tank Room – Spent gasoline line filters being stored outside the gasoline tank containment unit. D. Newsome

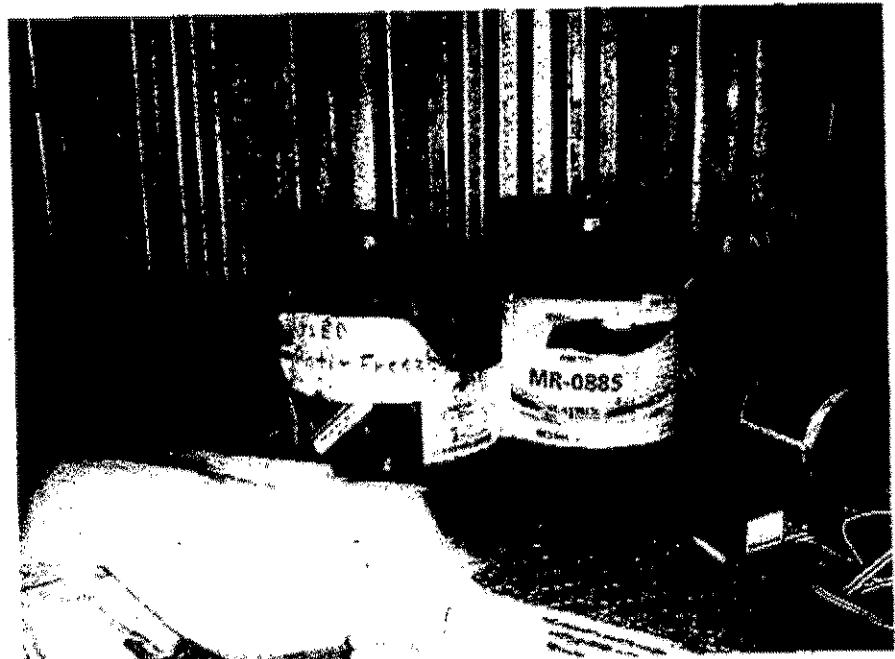
PHOTO 12, 2/9/2012 (facing NE) – Pop Hood Area – Two black approximately full unknown 5-gallon pails that were removed from scrap cars the beginning of last week (around 1/30/2012). One in poor condition and labeled used anti-freeze and the other had a product label for some type of finish. D. Newsome *DN*

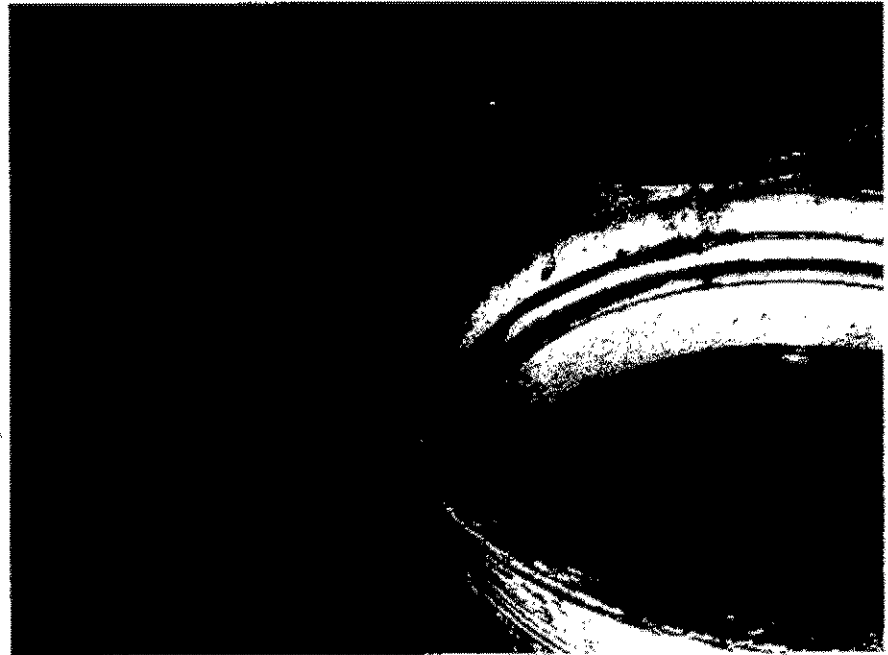
PHOTO 14, 2/9/2012 (facing SE) – Area that is NE of the Pop Hood Area – Close-up of the drums shown in photo 13. Drums of waste removed from the Rack Area used oil sump about 6 to 8 months ago. They were all open with no labels. D. Newsome

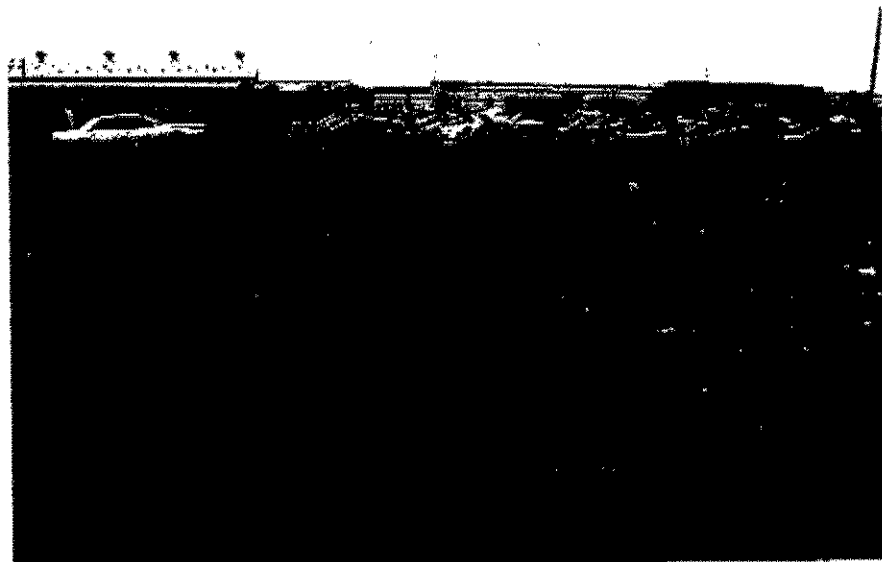
PHOTO 20, 2/9/2012 (facing NW) – Area on West Side of Site (see attachment 8C for photo location) – Apparent oil spills and stains observed on the ground and stain leading to drain. Close-ups shown in photos 21 through 24. D. Newsome

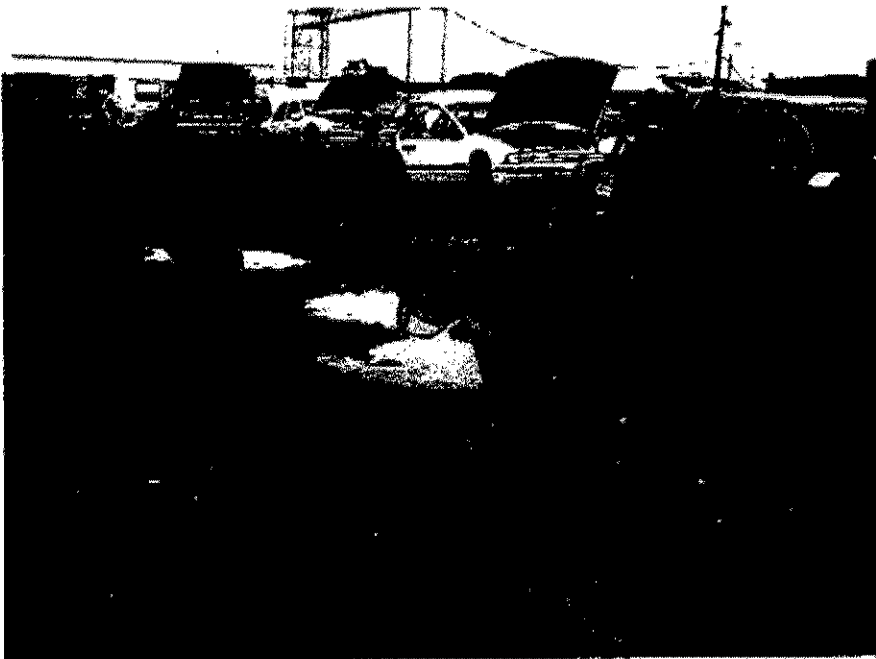
PHOTO 25, 2/9/2012 (facing NE) – Area on West Side of Site (see attachment 8C for photo location) – Apparent oil spills and stains observed on a concrete pad with no containment and water puddle with oil sheen next to pad. Close-ups shown in photos 26 and 27.
D. Newsome

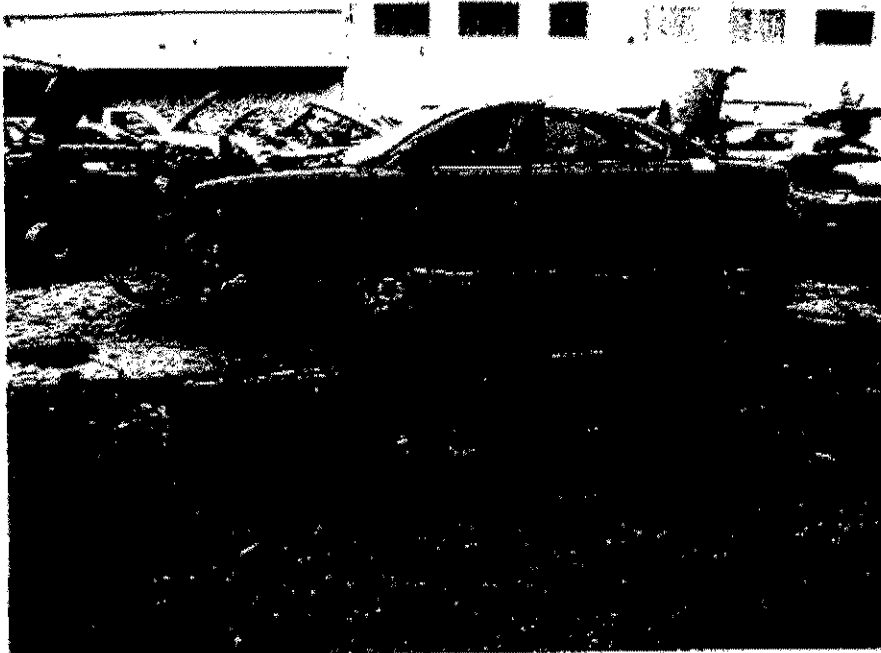
PHOTO 27, 2/9/2012 (facing E) – Area on West Side of Site (see attachment 8C for photo location) – Close-up of oil spills and stains and water puddle in photo 25. D. Newsome

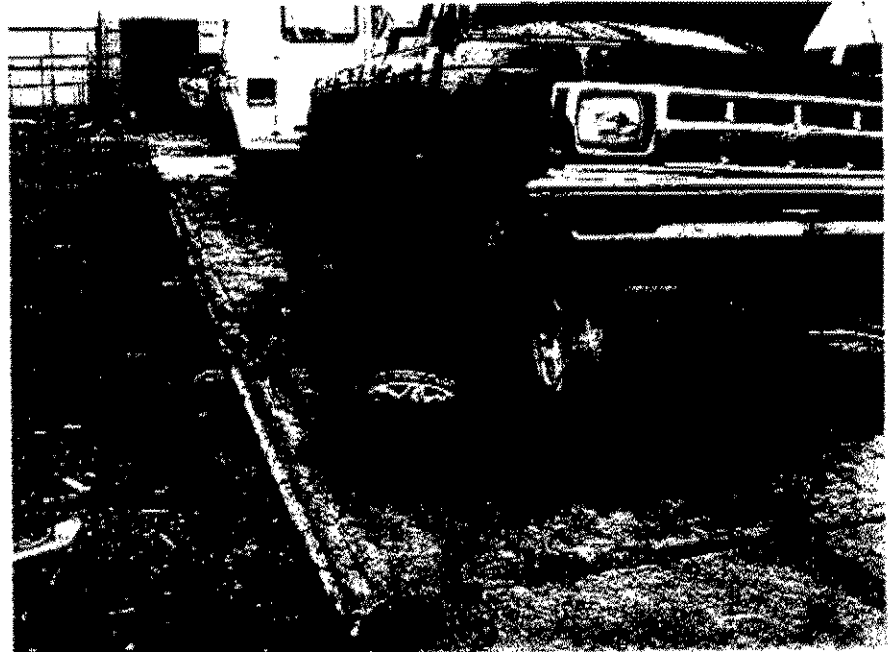
PHOTO 28, 2/9/2012 (facing NE) – Area on West Side of Site (see attachment 8C for photo location) – Apparent oil spills and stains observed on a concrete pad with no containment. D. Newsome

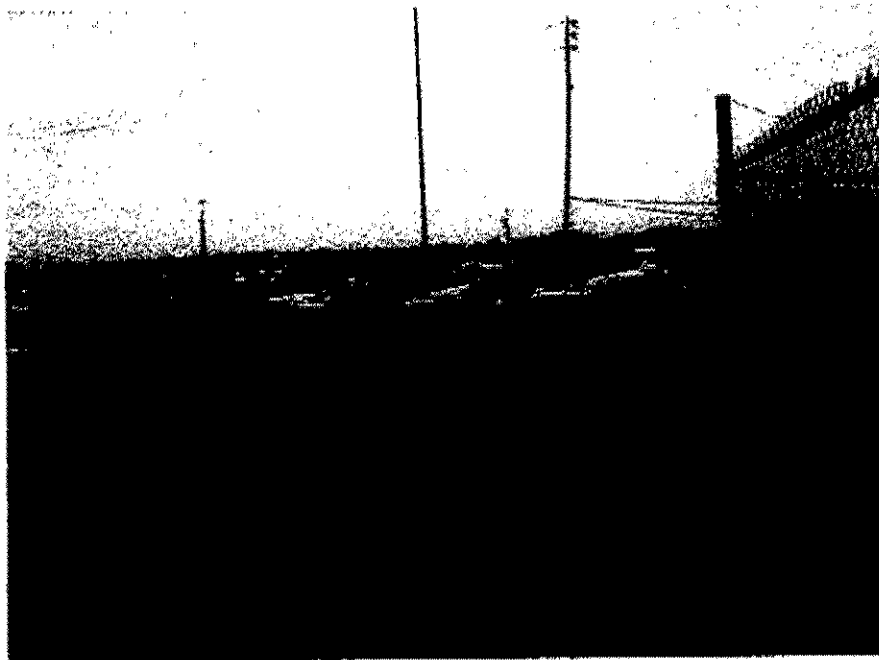
PHOTO 29, 2/9/2012 (facing NW) – Area on West Side of Site (see attachment 8C for photo location) – Apparent oil stains observed tracked on dirt drive way between the rows of scrap cars.
D. Newsome *DN*

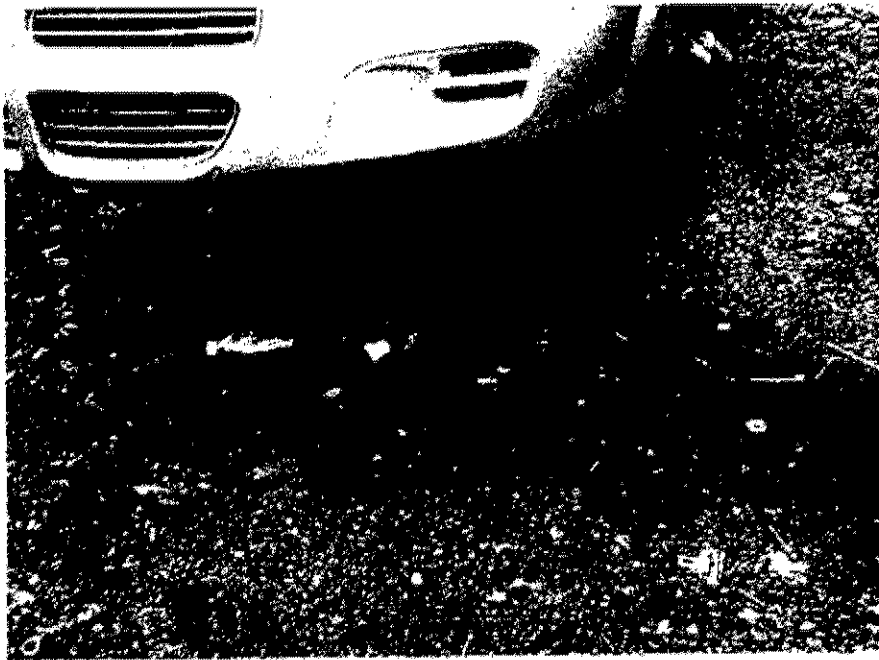
PHOTO 31, 2/9/2012 (facing SE) – Area on North Side of Site (see attachment 8C for photo location) – Apparent oil spills and stains observed on concrete pad that Mr. Moran believed was covered in millings to fill in holes in the concrete pad over the years.
D. Newsome *DN*

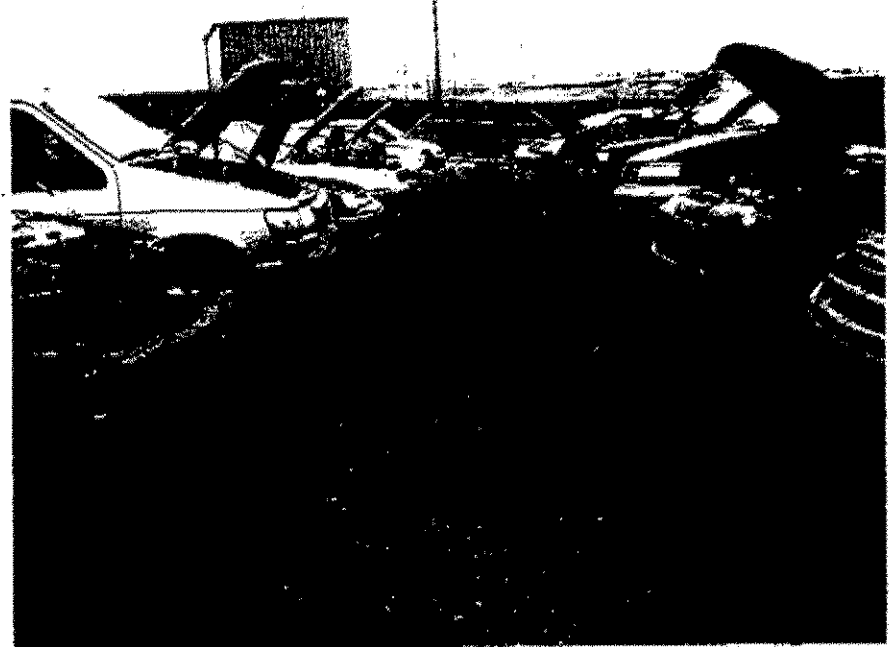
PHOTO 32, 2/9/2012 (facing W) – Area on North Side of Site (see attachment 8C for photo location) – Apparent oil stains observed on concrete pad that Mr. Moran believed was covered in millings to fill in holes in the concrete pad over the years.
D. Newsome *DN*

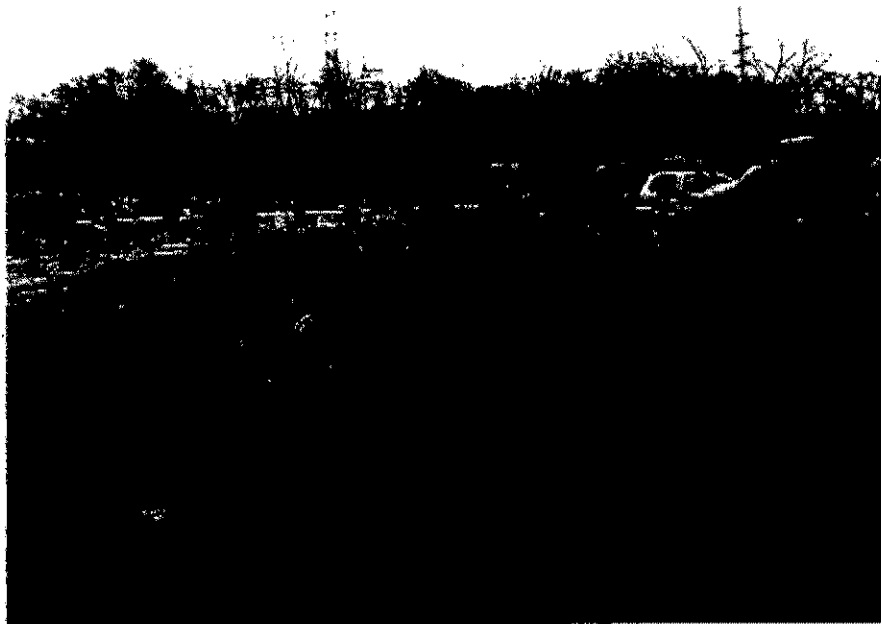
PHOTO 33, 2/9/2012 (facing E) – Area on North Side of Site (see attachment 8C for photo location) – Apparent oil stains observed on concrete pad that Mr. Moran believed was covered in millings to fill in holes in the concrete pad over the years. D. Newsome

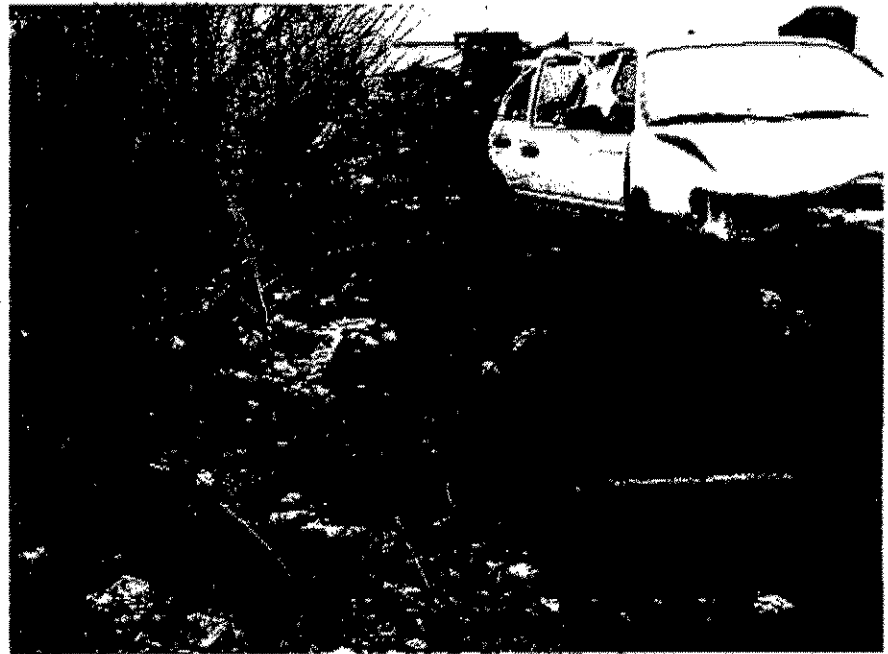
PHOTO 34, 2/9/2012 (facing N) – Area on East Side of Site (see attachment 8C for photo location) – Apparent oil stains observed on a concrete pad with no containment and ground. D. Newsome

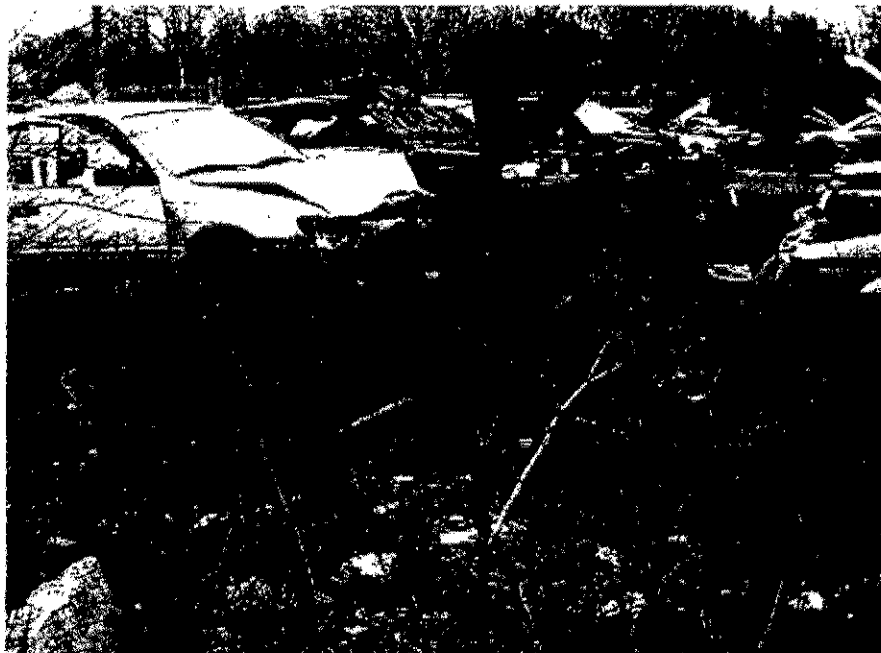
PHOTO 35, 2/9/2012 (facing NE) – Area on East Side of Site (see attachment 8C for photo location) – Apparent oil stains observed on a concrete pad with no containment and ground. D. Newsome

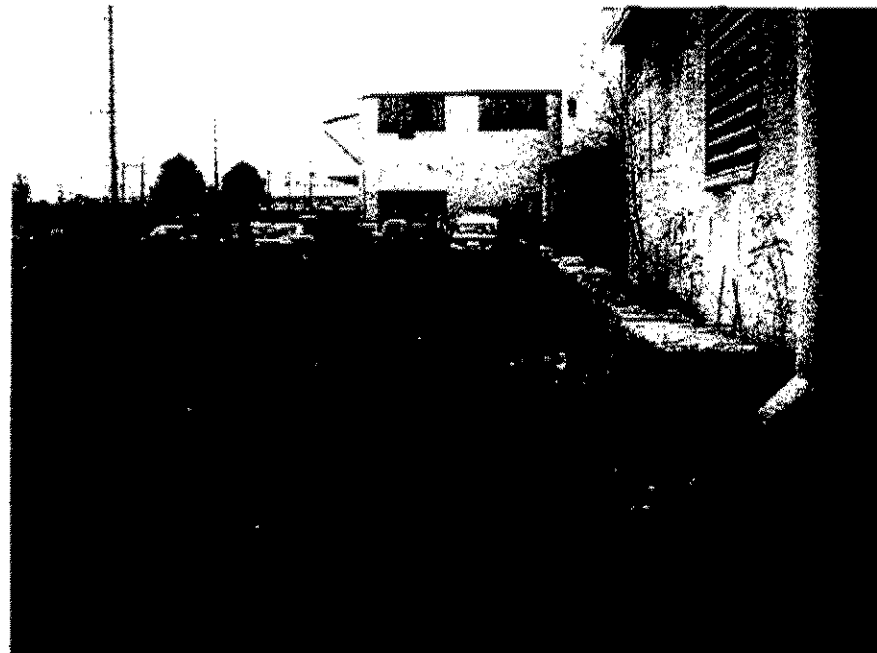
PHOTO 36, 2/9/2012 (facing S) – Area on East Side of Site (see attachment 8C for photo location) – Apparent oil stains observed on a concrete pad with no containment and ground. D. Newsome

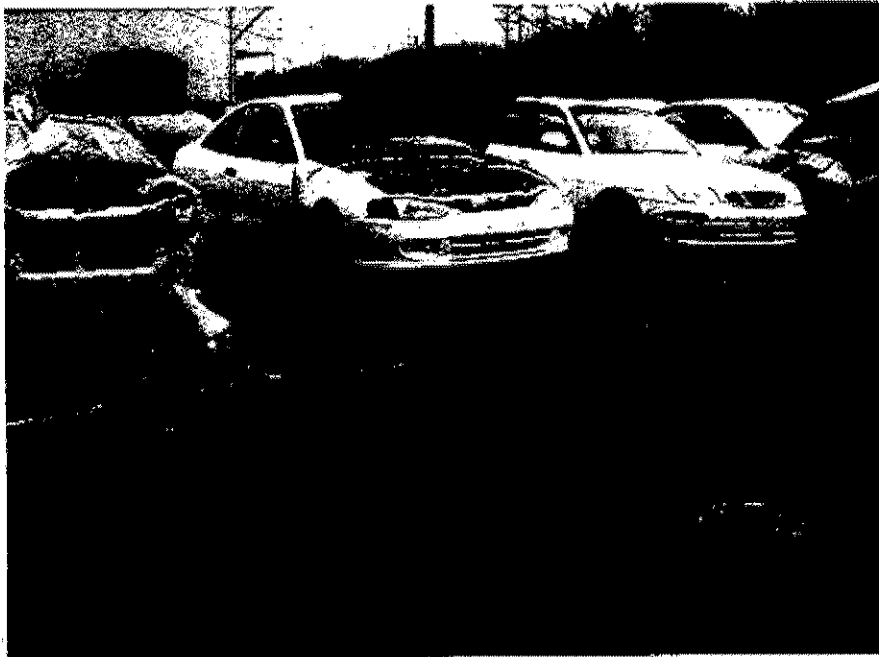
PHOTO 37, 2/9/2012 (facing NE) – Area on East Side of Site (see attachment 8C for photo location) – Apparent oil stains observed on a concrete pad with no containment and ground. D. Newsome *DN*

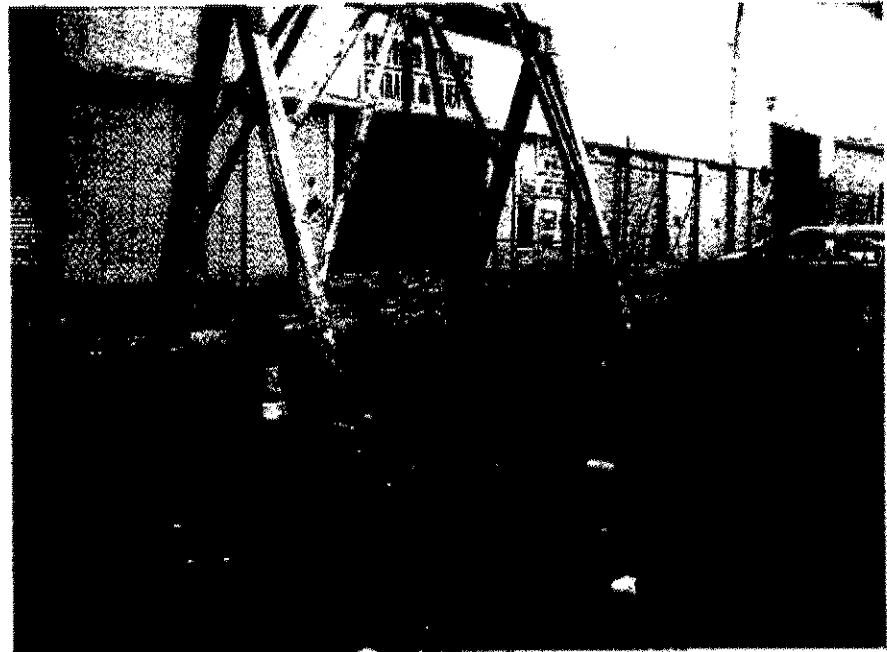
PHOTO 48, 2/10/2012 (facing NE) – Area on South Side of Site at Customer Entrance (see attachment 8C for photo location) – Apparent oil stains observed on the concrete ground under yellow engine hoist leading to drain located behind concrete barriers. Close-ups shown in photos 49 and 50. D. Newsome

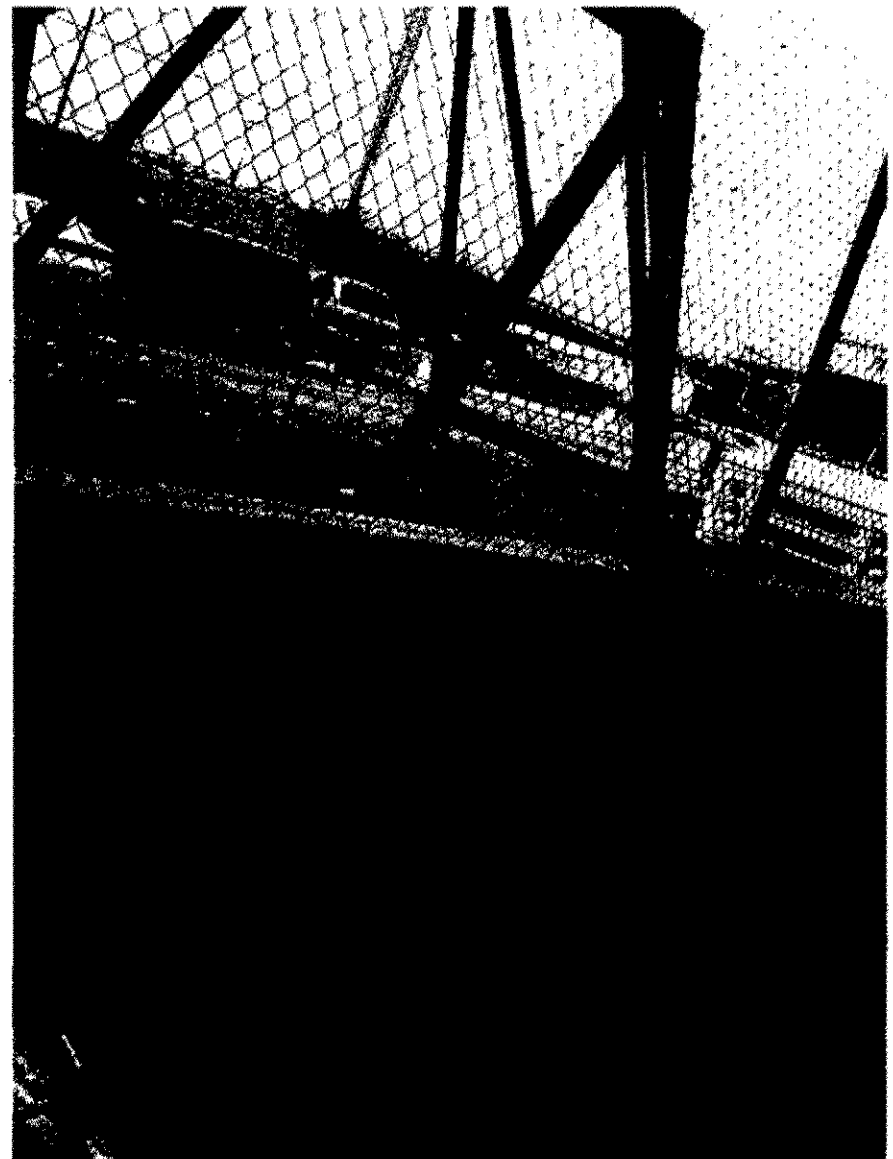
PHOTO 50, 2/10/2012 (facing SW) – Area on South Side of Site at Customer Entrance (see attachment 8C for photo location) – Apparent oil stains observed on the concrete ground under yellow engine heist leading to drain located behind concrete barriers shown in photos 48 and 49. D. Newsome
